## Service Bulletin

### BALANCE WEIGHT RECEPTACLE INSPECTION

**NOTICE No.:** 33000-4R2  
**DATE:** 3 August 2021  
 Page 7 of 7

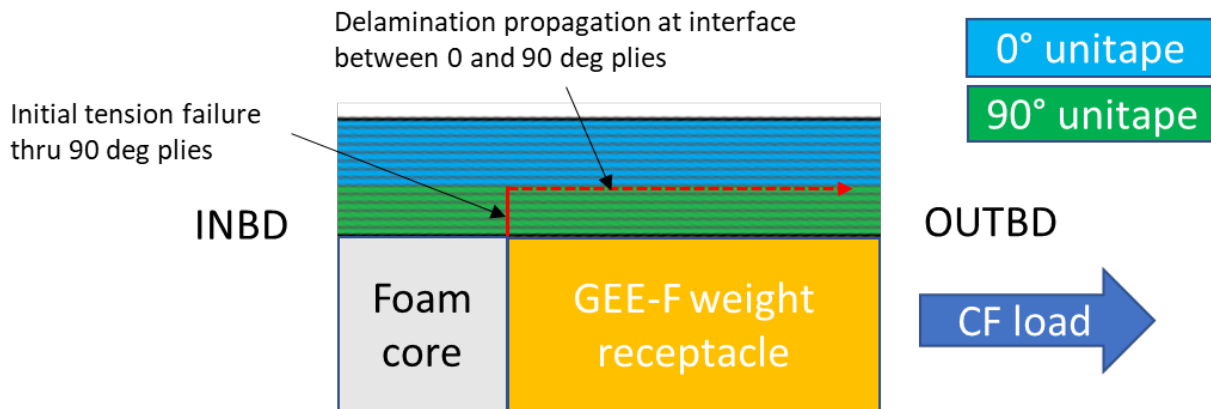
The weight of the receptacle, lump mass, and balance weights in conjunction with the high rotational speed near the tip results in a large centrifugal force (CF) acting on the weight receptacle. This centrifugal force acts radially outward from the center of the hub and is reacted by the spar laminate via the film adhesive bond. This load is therefore acting perpendicular to the fiber direction of the 90° plies. The material is much weaker in this direction which causes the fibers to be pulled apart, resulting in a crack along the inboard edge of the weight receptacle. This crack extends through the thickness of the 90° plies (ref. Figure 1) until it reaches the interface to the 0° plies. Because of their orientation, the fibers in the 0° plies are aligned with the centrifugal load, making them much stronger and so they do not fail. Instead, the crack turns 90° and propagates outboard as a delamination between the 0° and 90° plies.

Figure 1 - Cross-Sectional Schematic of Failure and Damage progression (looking from TE toward LE)

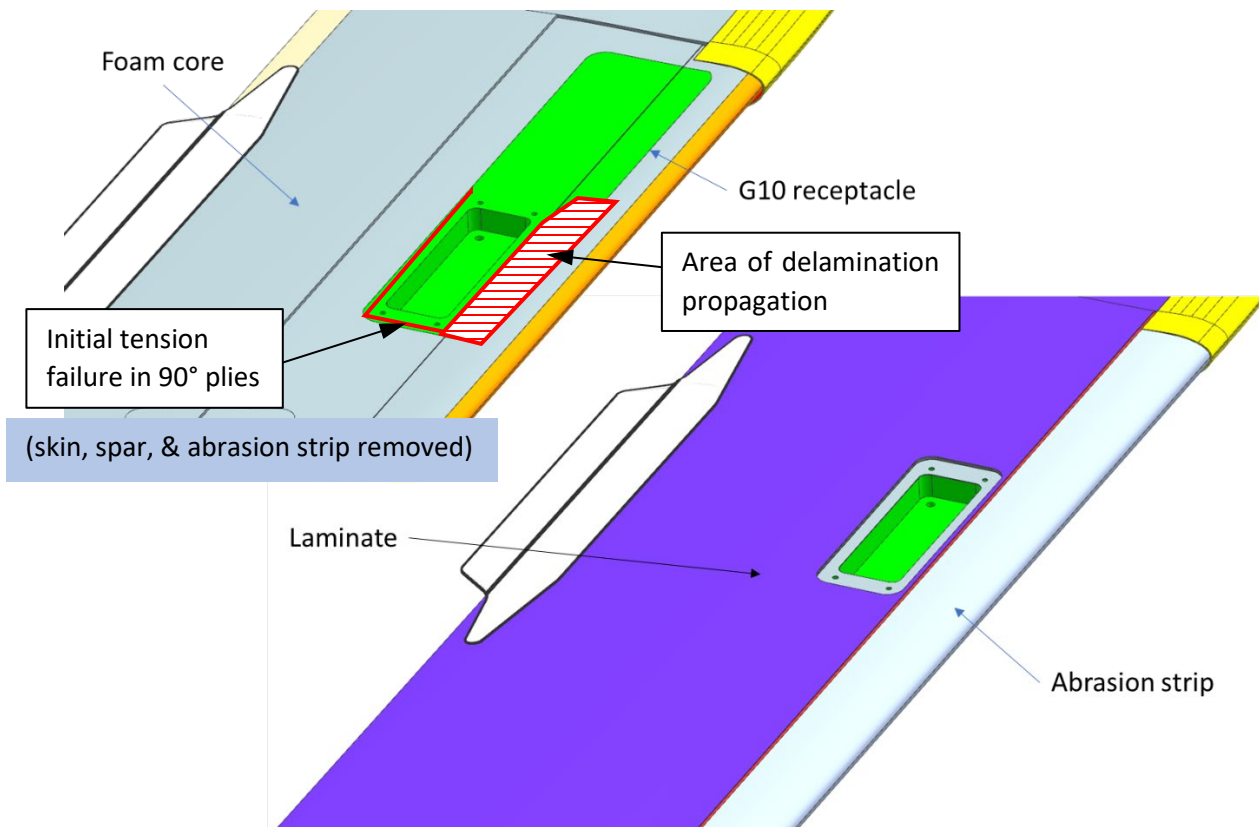
quasi-statically to a length of approximately 1-2 inches. Thereafter, the delamination grows more slowly in a stable, predictable manner and is readily detectable by conventional tap testing techniques. The delamination develops first on the lower (flat) surface and grows outboard from the inboard end of the weight receptacle and forward of the balance weight pocket (ref. Figure 2). After significant growth of the delamination on the lower surface (approximately 4 to 6 inches), a similar delamination becomes detectable growing from the inboard edge of the weight receptacle on the upper (curved) surface of the blade. Both delaminations continue to grow until they reach 8 to 10 inches in length, at which point static overload occurs and the receptacle would be expected to depart the blade.

Figure 2 - Location of the Delamination on the Lower Surface and Internal Structure

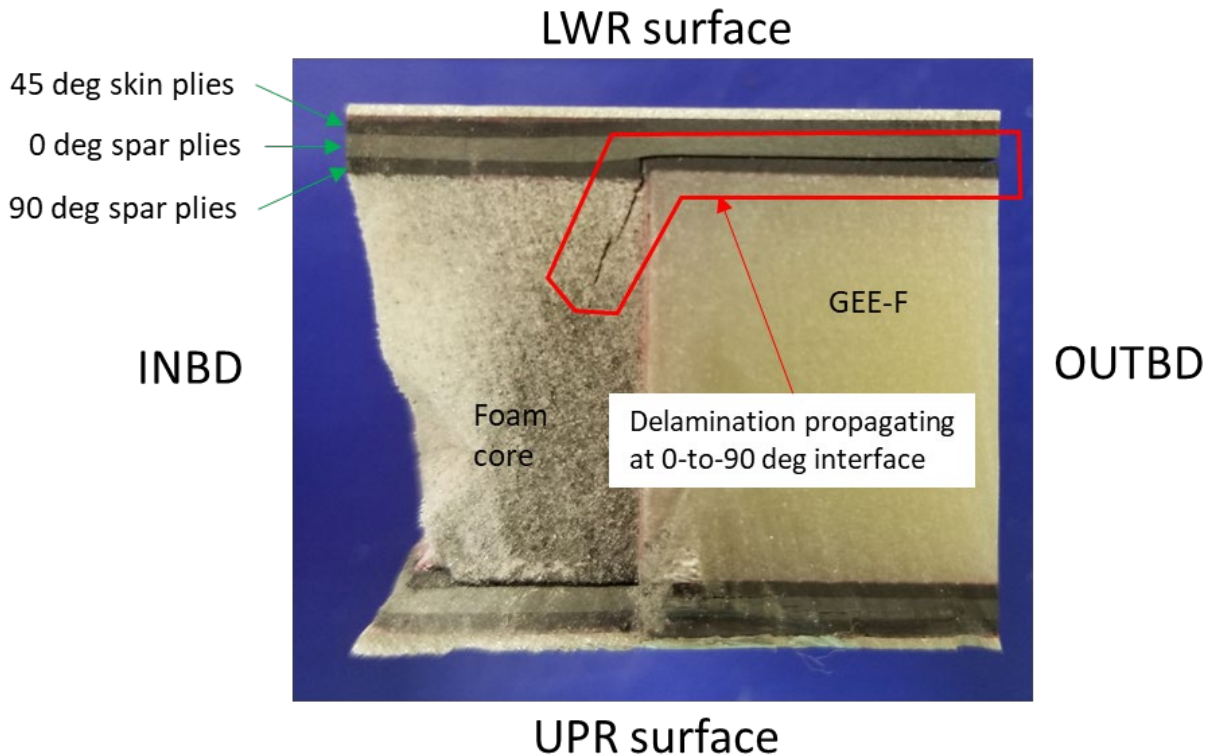
Company testing has confirmed that the 90° plies fail in spanwise tension (normal to the fiber direction) at the inboard end of the weight receptacle near rotor blade station 186.0. A delamination then propagates outboard from rotor blade station 186.0 at the interface between the 0° and 90° plies (ref. Figure 3). Fatigue testing has shown that the delamination initiates almost immediately and progresses

Figure 3 - Test Specimen Cross-Section Showing Damage Progression

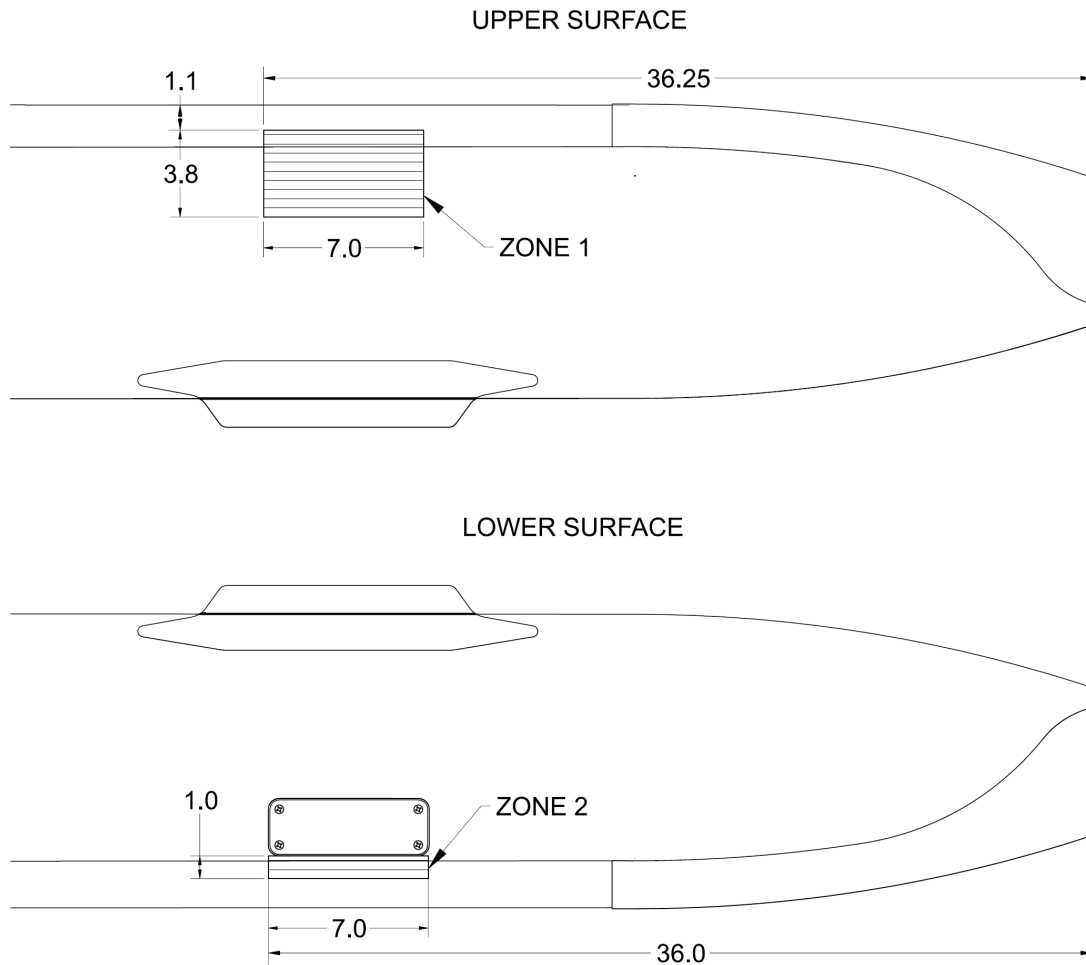
- (5) **NOTE:** The delamination on the lower surface originates from the inboard, aft corner of Zone 2 near the inboard end of the weight pocket cover and grows forward and outboard from there. On the upper surface, delamination initiates near the center of the inboard edge of Zone 1 and grows outboard. Delamination on the upper surface will likely not be detectable until a significant delamination has already developed on the lower surface. Also, a significant tone change will be heard if tapping is continued farther inboard of the inspection area where the weight receptacle ends and the internal material changes to foam core. This should not be noted as a delamination.

Figure 4 – Tap Inspection Locations with Grid Markings (Zone 1 & Zone 2)

- (1) Do not remove the weight receptacle cover plate. The cover plate does not affect the results of the tap inspection.
- (2) Use a permanent marker and draw inspection Zone 1 on the upper surface of the blade, and draw inspection Zone 2 on the lower surface of the blade as shown in Figure 4. Draw parallel lines from the inboard end of the inspection zones to the outboard end of the inspection zones with the lines spaced 0.5 inches apart.

- (4) Use a tap hammer and tap inspect the area within each inspection zone. Start from the outboard end of each inspection zone and tap repeatedly along a parallel line while moving inboard. A change in the sound of the tap from a solid response to a flat, deadened tone indicates the presence of a delamination. Mark the location where the delamination starts. Repeat the tap inspection along the adjacent lines until the entire area is inspected and the full extent of the delamination is marked.

- (8) Once the delamination has reached a size of 6.0 inches on the lower surface, remove the blade from service and contact VHA for disposition.
- (9) **NOTE:** It is expected that a delamination length of approximately 2" may be present at the first inspection. This DOES NOT mean that 1/3 of the blade life has been consumed. As discussed above, growth progresses more slowly after the initial delamination is developed.
