INSTRUCTIONS FOR CONTINUED AIRWORTHINESS

ICA MANUAL No. VMM-206B-301

Tail Rotor Blade Assembly 2062200-101/-301
Eligible for Installation on Model 206A/B

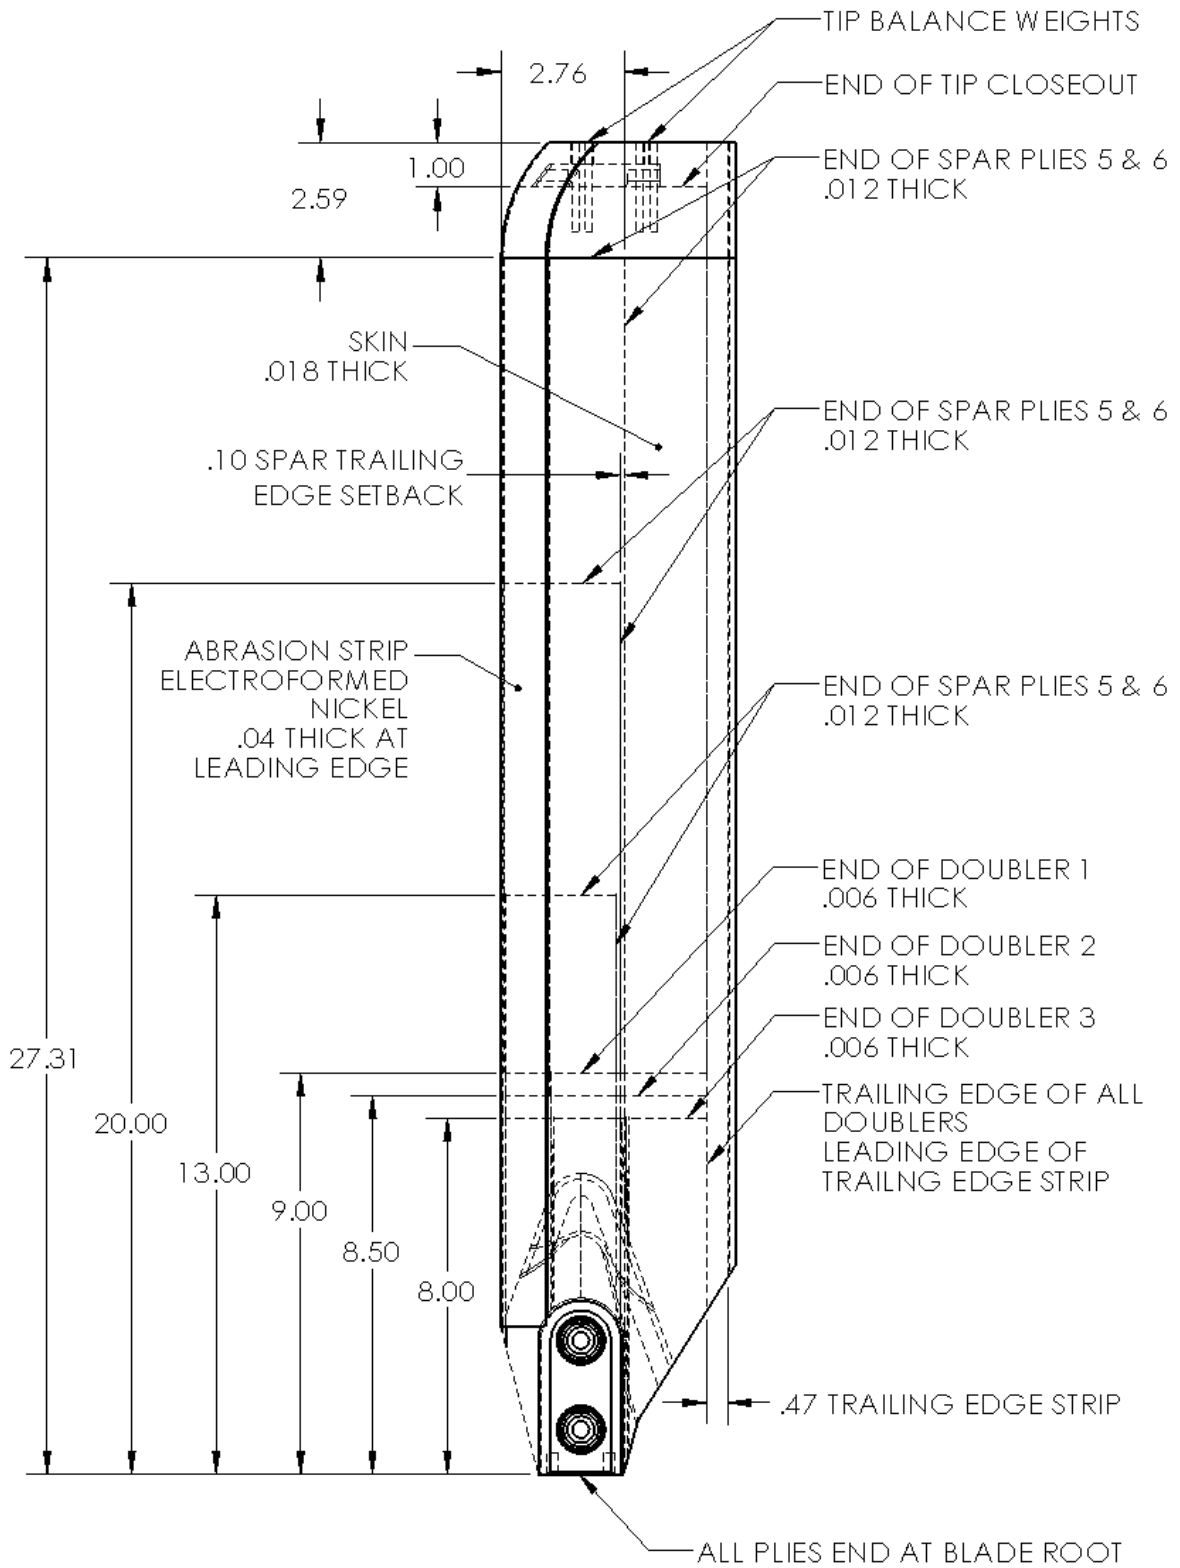
Figure 5.3
Tail Rotor Blade

Impact damage may progress from little evidence of external damage to puncture with surrounding voids depending on impact force. In all cases of suspected skin damage, a tap test is required to determine extent of the damage. Figure 5.3 shows the blade internal components including locations of ply drop-offs. Take note of the various thicknesses and ply drop-off locations. A tonal change may occur at these drop-offs when tapping across them depending on tapping force. If suspected damage is on or near a ply drop-off, it may be required to tap an undamaged blade in the same area to help distinguish a tonal change from a void.

- d. Tap test an area 1.0 inch either side of the dent for voids. See Figure 5.3 for locations of ply drop-offs. A tonal change may occur at these drop-offs when tapping across them depending on tapping force. If a dent is on or near a ply drop-off, it may be required to tap an undamaged blade in the same area to help distinguish a tonal change from a void.

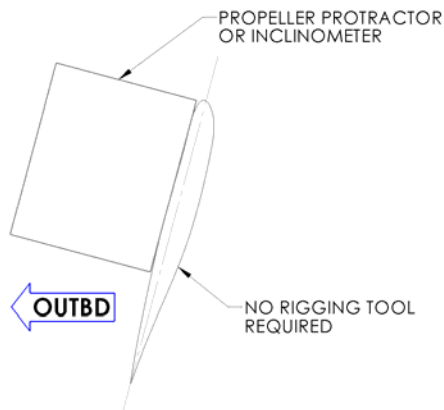
- a. 17.0° to 17.5° for helicopters with long tail rotor blades. S/N 4 through 2211 modified per 62.3.2, and S/N 2212 through 4004.
- b. 22.75° to 23.25° for helicopters S/N 4005 and subsequent.

62.3.4 Use protractor as shown in the figure below.
