## **INSTRUCTIONS FOR CONTINUED AIRWORTHINESS**

### **ICA MANUAL No. VMM-206L-303**

Tail Rotor Blade Assembly 2062200-101/-301  
Eligible for Installation on Model 206L

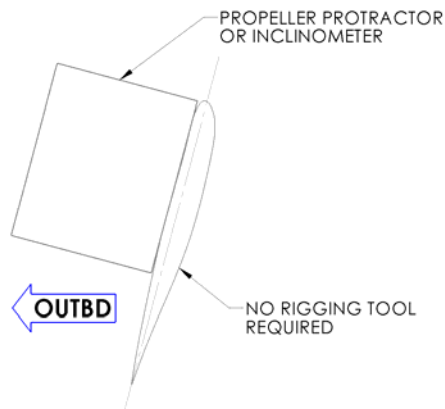
62.3.2 Mean blade angle to be 18.5° to 19.0°.

62.3.3 Use protractor as shown in the figure below.
