**Van Horn Aviation, L.L.C.**  
*1510 W. Drake Drive*  
*Tempe, Arizona 85283*

## **INSTRUCTIONS FOR CONTINUED AIRWORTHINESS**

### **ICA MANUAL No. VMM-OH58-311**

Tail Rotor Blade Assembly 2062200-101/-301  
Eligible for Installation on Arrow Falcon Exporters Inc.  
Model OH-58A+ and OH-58C Helicopters

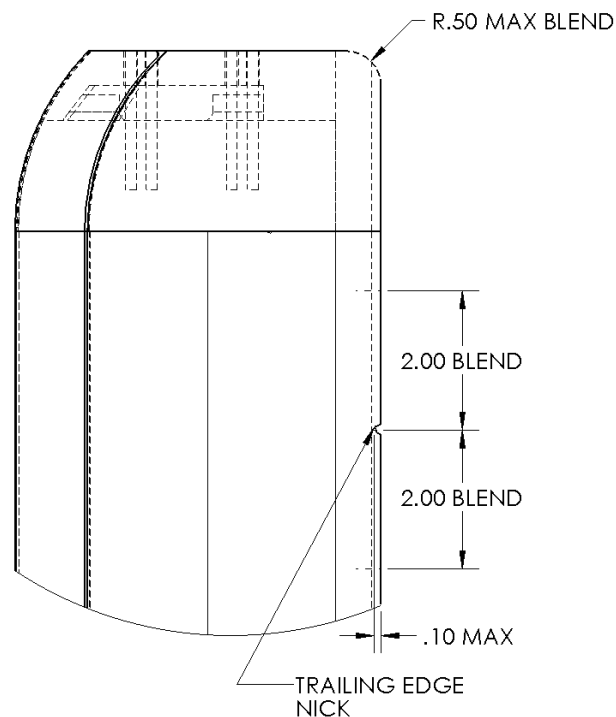
Figure 5.1  
Trailing Edge and Tip Damage Limits

- b. Voids not exceeding 1.00 inch diameter are acceptable at any location except for edge voids at the tip of the blade.
- c. Edge voids between the skin and tip closeout are not permitted.
- d. If voids are detected, remove paint in the damaged area to check for broken fibers. Remove paint and primer only. Do not sand into skin plies.
- e. Broken fibers are not permitted. If broken fibers are detected, send blade to an authorized FAA repair station for evaluation, and if possible, repair. Contact VHA for repair station recommendations.
- f. Scratches, nicks, or fiber damage in the extreme trailing edge 0.10 deep or less may be blended out over a distance of at least 2.0 inches each side of the damage. See Figure 5.1 below.
- g. Damage at the tip trailing edge may be removed by blending up to a 0.50 inch radius at the tip. See Figure 5.1 below.

- a. Voids are not allowed within 0.50 inch of the trailing edge.

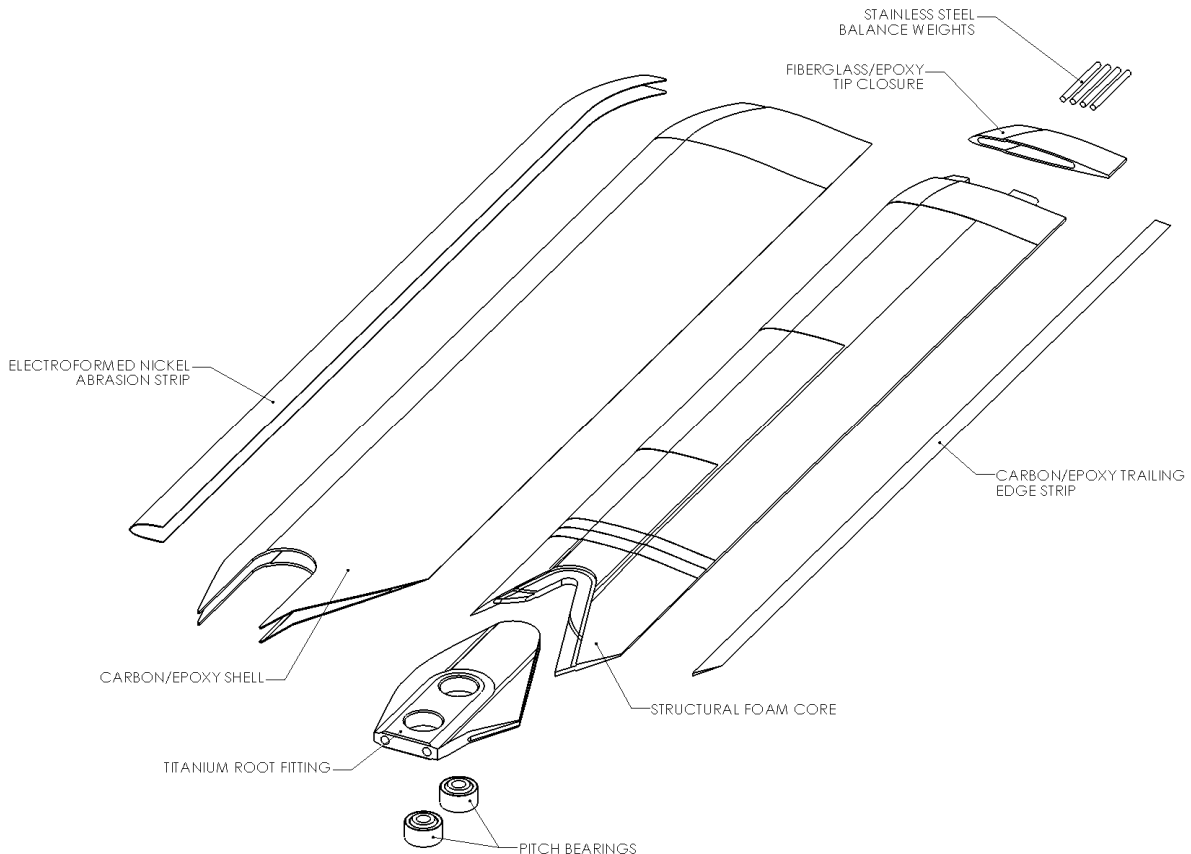
Figure 62.1.1  
Tail Rotor Blade Description

The 2062200-101/-301 tail rotor blade is a composite and metallic structure incorporating the NASA developed RC(4)-10(10% thick) rotor blade airfoil. This is a highly efficient laminar flow airfoil developed to have near zero pitching moments across a broad range of airspeeds. The blade radius is approximately .10 inches shorter than the existing production tail rotor blade. The blade chord length is the same as the existing blade at 5.25 inches. The tip of the blade is rounded to reduce noise and tip drag. The root fitting is machined from titanium alloy plate. The pitch bearings incorporate both a stainless steel race and sphere, and a Teflon liner. The sphere is chrome plated. The basic blade section is fabricated using unidirectional carbon/epoxy tape with a rigid cell structural foam core. Span balance is accomplished using threaded stainless steel screws in a fiberglass/epoxy high pressure laminate tip cap. An electroformed nickel abrasion strip is added for erosion protection.
