Van Horn Aviation, L.L.C.
1510 W. Drake Drive
Tempe, Arizona 85283

INSTRUCTIONS FOR CONTINUED AIRWORTHINESS

ICA MANUAL No. VMM-OH58-313

Tail Rotor Blade Assembly 2062200-101/-301
Eligible for Installation on Rotorcraft Development Corporation
Model OH-58A+ and OH-58C Helicopters

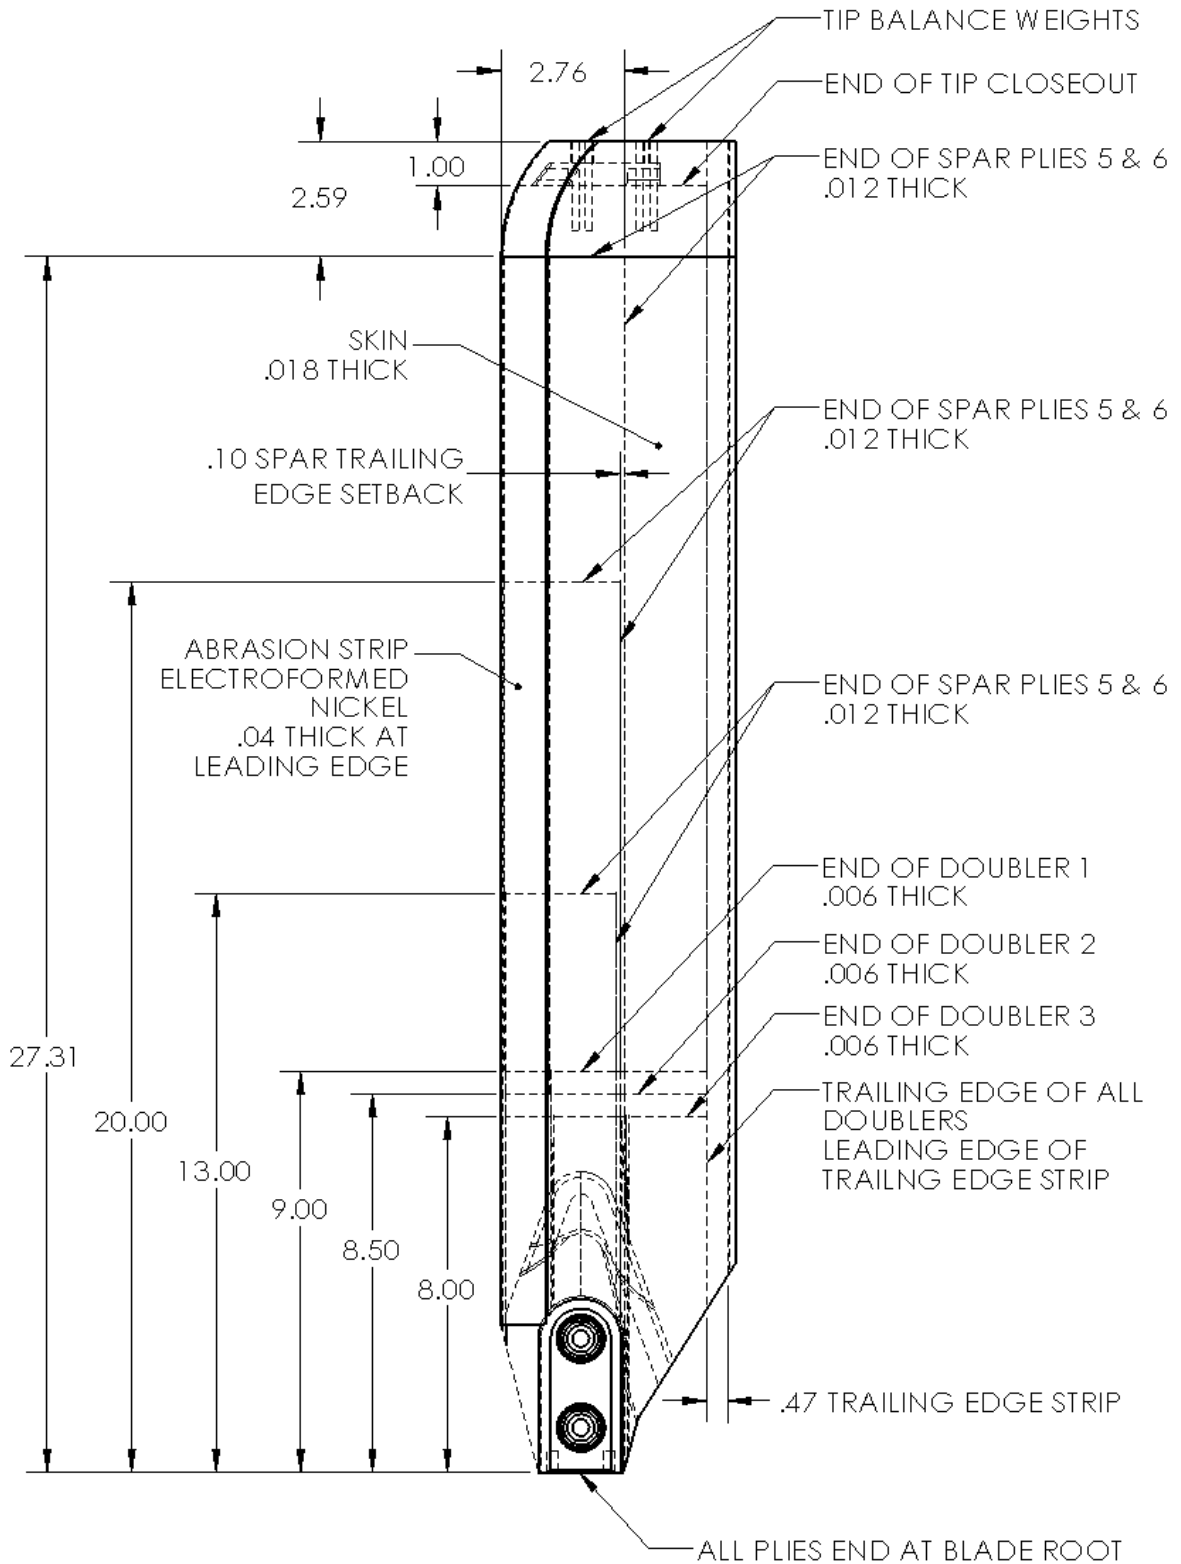
Figure 5.3
 Tail Rotor Blade

Impact damage may progress from little evidence of external damage to puncture with surrounding voids depending on impact force. In all cases of suspected skin damage, a tap test is required to determine extent of the damage. Figure 5.3 shows the blade internal components including locations of ply drop-offs. Take note of the various thicknesses and ply drop-off locations. A tonal change may occur at these drop-offs when tapping across them depending on tapping force. If suspected damage is on or near a ply drop-off, it may be required to tap an undamaged blade in the same area to help distinguish a tonal change from a void.

- d. Tap test an area 1.0 inch either side of the dent for voids. See Figure 5.3 for locations of ply drop-offs. A tonal change may occur at these drop-offs when tapping across them depending on tapping force. If a dent is on or near a ply drop-off, it may be required to tap an undamaged blade in the same area to help distinguish a tonal change from a void.
