INSTRUCTIONS FOR CONTINUED AIRWORTHINESS

ICA MANUAL No. VMM-OH58-315

Tail Rotor Blade Assembly 2062200-101/-301
Eligible for Installation on San Joaquin Helicopters
Model OH-58A+ and OH-58C Helicopters

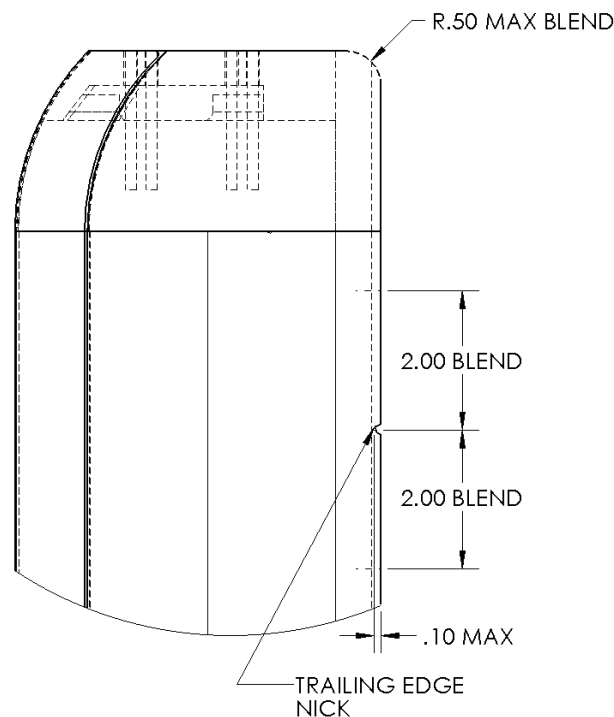
Figure 5.1
Trailing Edge and Tip Damage Limits

- b. Voids not exceeding 1.00 inch diameter are acceptable at any location except for edge voids at the tip of the blade.
- c. Edge voids between the skin and tip closeout are not permitted.
- d. If voids are detected, remove paint in the damaged area to check for broken fibers. Remove paint and primer only. Do not sand into skin plies.
- e. Broken fibers are not permitted. If broken fibers are detected, send blade to an authorized FAA repair station for evaluation, and if possible, repair. Contact VHA for repair station recommendations.
- f. Scratches, nicks, or fiber damage in the extreme trailing edge 0.10 deep or less may be blended out over a distance of at least 2.0 inches each side of the damage. See Figure 5.1 below.
- g. Damage at the tip trailing edge may be removed by blending up to a 0.50 inch radius at the tip. See Figure 5.1 below.

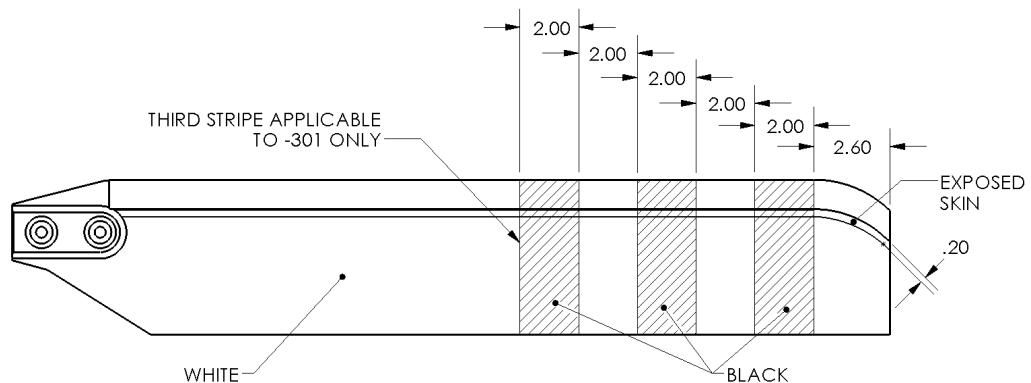
Figure 5.2
 Paint Color Scheme

VHA finishes the tail rotor blade using an epoxy surfacing film co-cured with the skin, epoxy paint primer, and polyurethane top coat. Basic blade color is white with 2.0 inch high visibility black stripes as shown in Figure 5.2.

- b. Paint wear due to erosion at the tip may expose the carbon/epoxy skin to ultra violet radiation and moisture absorption.
- c. Exposed skin not exceeding 0.20 inch aft of abrasion strip trailing edge must be protected by at least one coat of epoxy primer within 25 flight hours of exposure. See Figure 5.2.

- d. Exposed skin exceeding 0.20 inch aft of abrasion strip trailing edge must be protected by at least one coat of epoxy primer within 10 flight hours of exposure. See Figure 5.2.

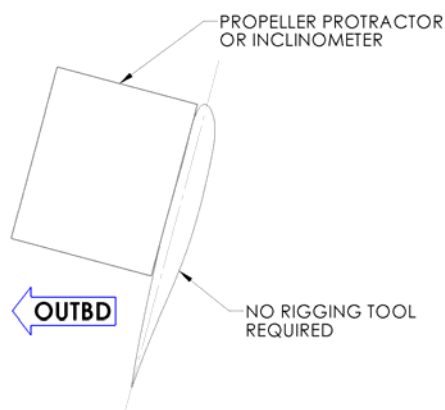
62.3.2 Blade angles are reduced by 0.5°. Subtract 0.5° degrees from the high and low blade angles in Army Technical Manual TM55-1520-228-23-2. For example if Army Technical Manual TM55-1520-228-23-2 calls for 22.0° to 23.0°, rig the 2062200-101/-301 blades to 21.5° to 22.5°. Except for the reduced angle, rig the blades per Army Technical Manual TM55-1520-228-23-2 and the figure below.
