INSTRUCTIONS FOR CONTINUED AIRWORTHINESS

ICA MANUAL No. VMM-UH1-305

Tail Rotor Blade Assembly 2042200-101/-103
Eligible for Installation on Richard's Heavylift Helo, Inc.
(S.M. & T.) UH-1H
Reference Van Horn Aviation, L.L.C. STC SR02051LA

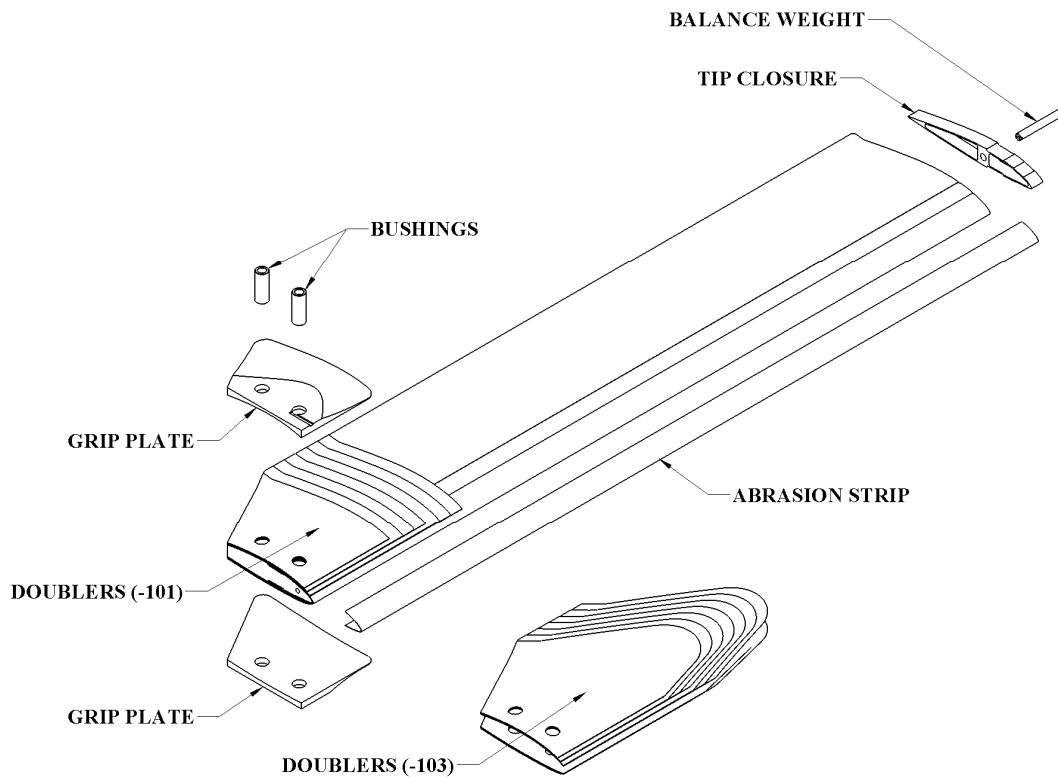
Figure 60.2.1
Tail Rotor Blade Description

The 2042200-101/-103 tail rotor blade is an all composite blade employing an advanced highly efficient airfoil. The blade length is the same as the existing production blade, but the width of the blade is .80 inches longer. Erosion protection is provided by a full span stainless steel abrasion strip adhesively bonded to the leading edge. Stainless steel bushings are pressed into the inboard end to react the attachment bolt loads. The blade is constructed primarily of carbon/epoxy unidirectional tape. The grip plates, tip closure and root closure are fabricated from fiberglass/epoxy fabric. The blade is statically balanced at the factory using a brass balance weight threaded into the tip closure. The interior of the blade is filled with closed cell rigid foam. The only difference between the -101 and -103 configurations is the doubler outboard trim.
