INSTRUCTIONS FOR CONTINUED AIRWORTHINESS

ICA MANUAL No. VMM-MR-206B-501

Main Rotor Blade Assembly 20631000-101
Eligible for Installation on Model 206B

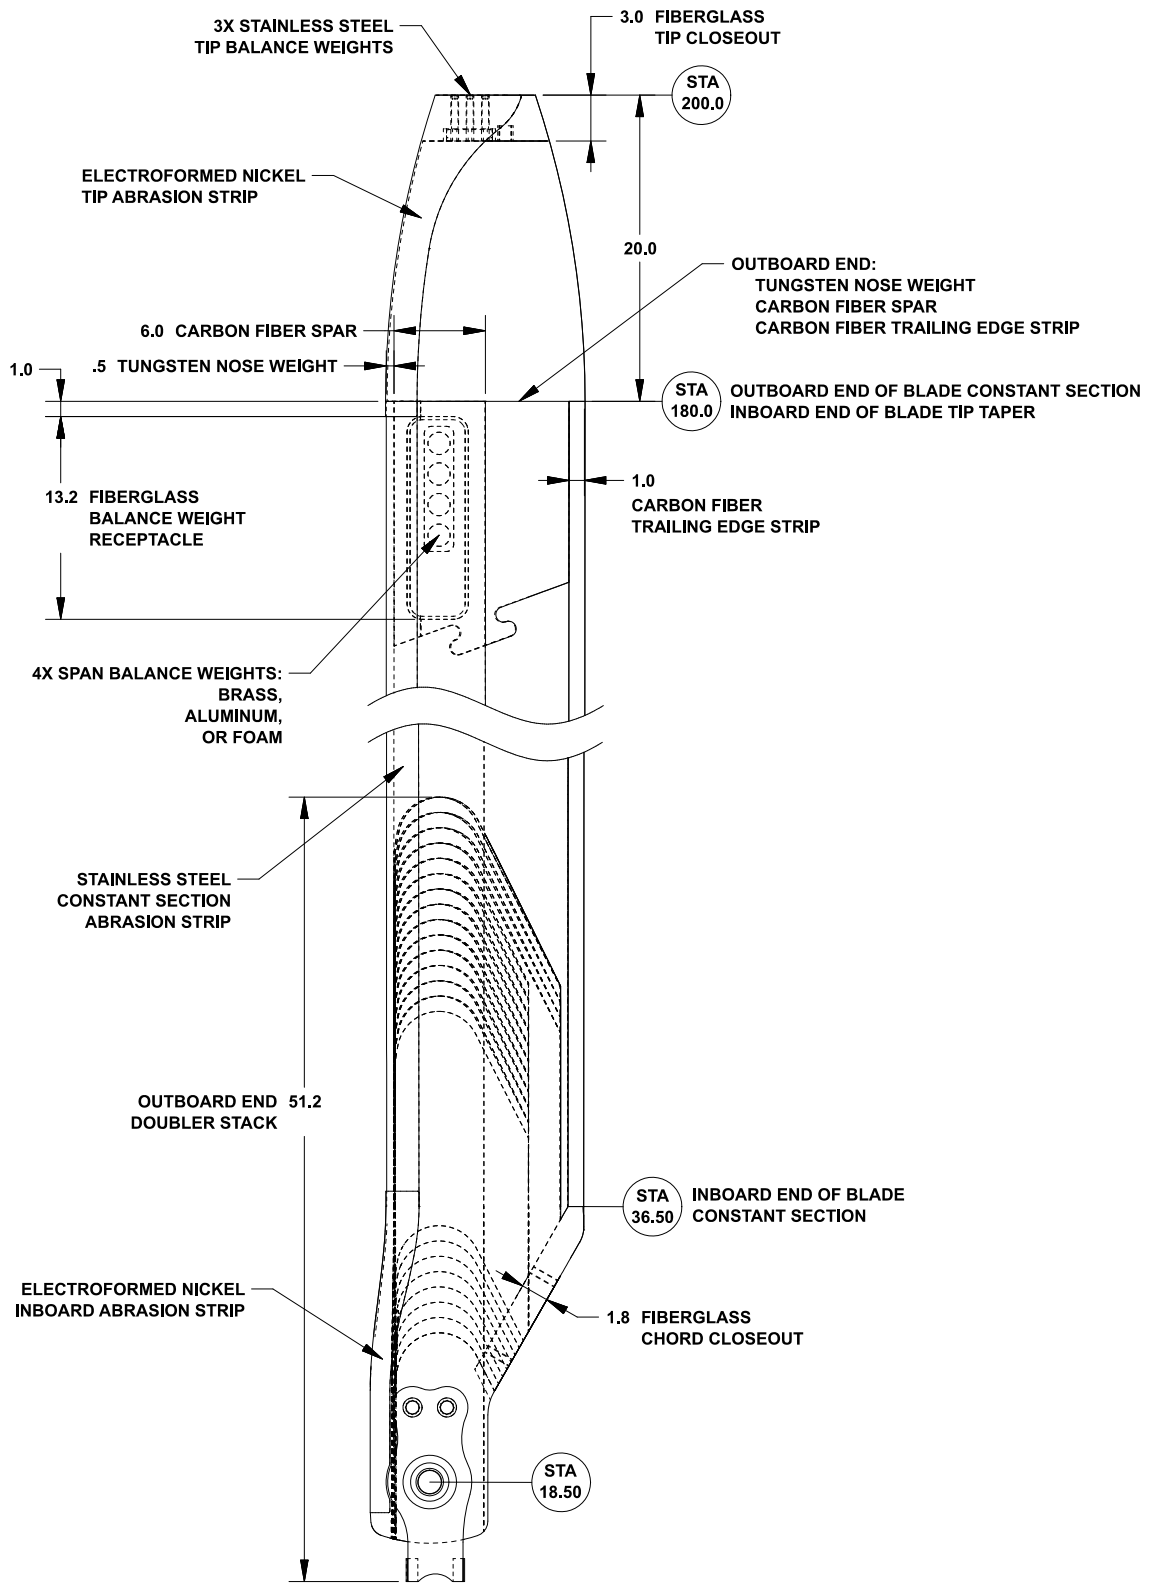
*The internal structure of the blade will cause tone changes during the tap test. Figure 5-1 shows the blades' internal components with their approximate locations and shapes. Other than the components shown, the remainder of the blades' internal structure is high density structural foam. Tone changes can be expected as the tap test traverses the various blade sections. Tone changes that are not associated with internal component boundaries should be treated as suspected voids.

Figure 5-1
Blade Internal Component Locations and Shapes

No.	Inspection Requirements	Airworthiness Criteria
1.	Inspect grip plate assemblies, root plates, and bushings for cracks. Conduct a tap test of blade upper and lower surface*.	Contact Van Horn Aviation if any discrepancies found exceeding damage limits in 5.10 and for grip plate assembly installation instructions.

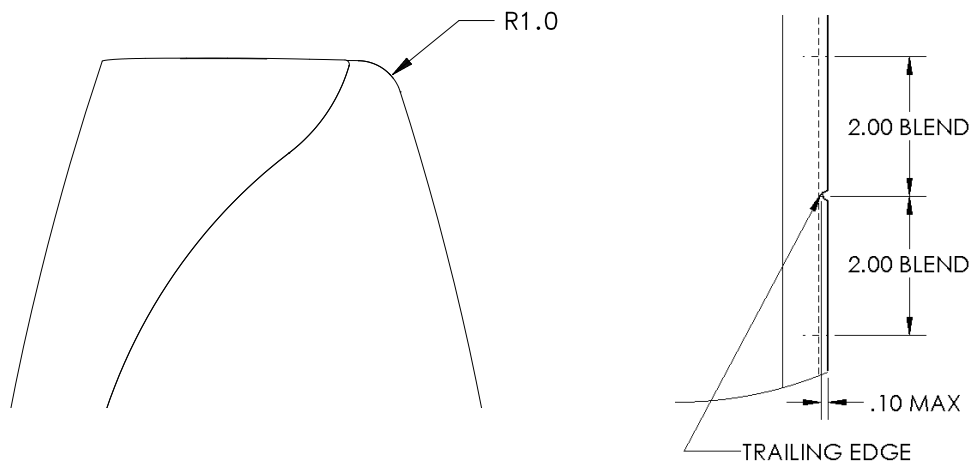
- a. Voids are not allowed within 1.0 inch of the trailing edge.
- b. Voids not exceeding 1.0 inch diameter are acceptable at any spanwise location.
- c. If voids are detected, remove paint in the damaged area to check for broken fibers. Remove paint and primer only. Do not sand into skin plies.
- d. Broken fibers are not permitted. If broken fibers are detected, send blade to an authorized FAA repair station for evaluation, and if possible, repair. Contact VHA for repair station recommendations
- e. Scratches, nicks, or fiber damage in the extreme trailing edge 0.10 deep or less may be blended out over a distance of at least 2.0 inches each side of the damage. See Figure 5-2 below.
- f. Damage at the tip trailing edge may be removed by blending up to a 1.0 inch radius at the tip. See Figure 5-2 below.

Figure 5-2
Tip and Trailing Edge Damage Limits

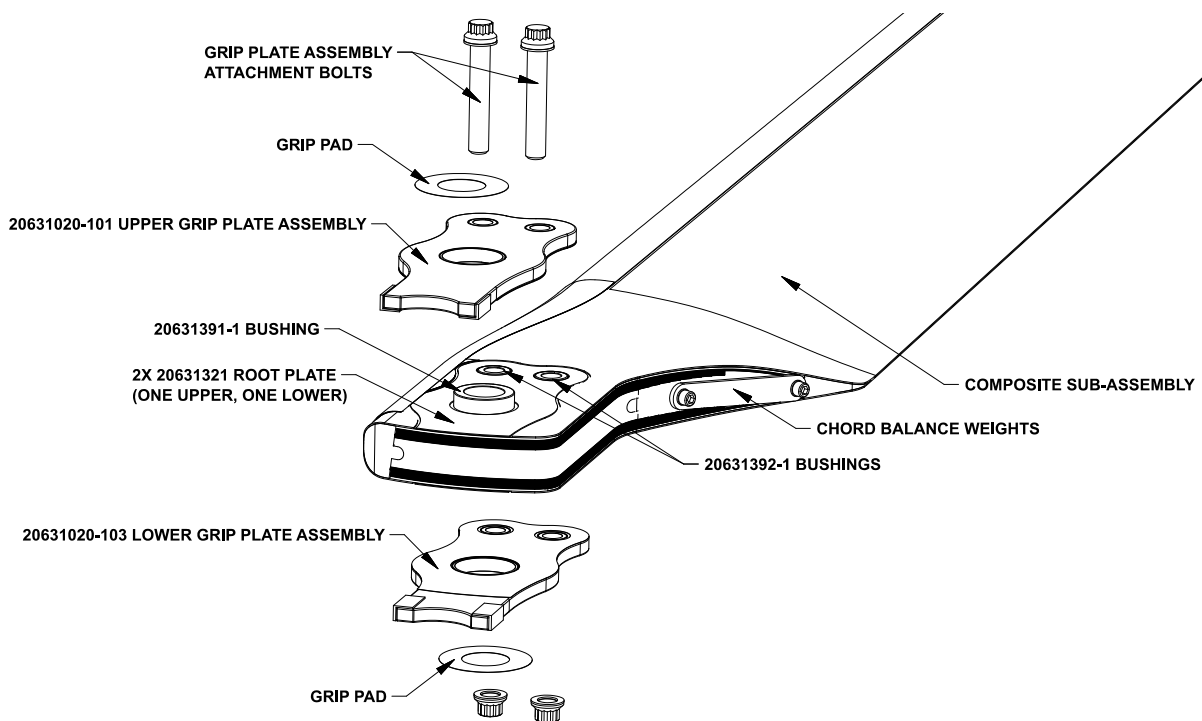
The 20631000-101 main rotor blade is a composite and metallic structure incorporating the NASA-developed RC(4)-12(12% thick) rotor blade airfoil. This is a highly efficient laminar flow airfoil developed to have near zero pitching moments across a broad range of airspeeds. The blade radius and chord is the same as the existing production blade except that the tip of the blade is tapered to reduce noise and tip drag. The root fitting is machined titanium alloy plate fastened to the blade root using two .750-inch bolts. Stainless steel bushings are bonded into the root of the blade. The basic blade section is fabricated using unidirectional carbon/epoxy tape and plain weave carbon/epoxy fabric with a rigid cell structural foam core. Span balance is accomplished using cylindrical weights bonded into a fiberglass/epoxy high pressure laminate sheet receptacle and threaded stainless steel screws in a fiberglass/epoxy high pressure laminate tip cap. Electroformed nickel and stainless steel abrasion strips are added for erosion protection.

Figure 62-1
Main Rotor Blade Description

REV	DATE	DESCRIPTION	APPROVED
N/C	01/27/16	Initial Release	JVH
A	02/02/16	Updated section 4, airworthiness schedule. Added bushing and grip plate inspections. Updated figure 62-1.	JVH
B	02/10/16	Updated section 4, airworthiness schedule.	JVH
C	04/29/16	Updated section 4, airworthiness schedule.	JVH
D	06/08/16	Corrected Grip Assembly part numbers in 62.2.	JVH
E	12/19/16	Expanded 5.10.1 Damage Description. Revised 5.10.4(c.)(d) to add a time requirement in addition to an hour requirement for exposed carbon/epoxy skin aft of abrasion strip trailing edge. Added tap test of blade in 5.4 and 5.5. Renamed figure 5-1 to 5-2. Added new figure 5-1. Revised 62.3.2(c.) to permit use of reflective tape in addition to tracking tabs and permits use of Bell approved trim tab bending and angle measuring tools. Deleted NOTE in 62.3.	JVH

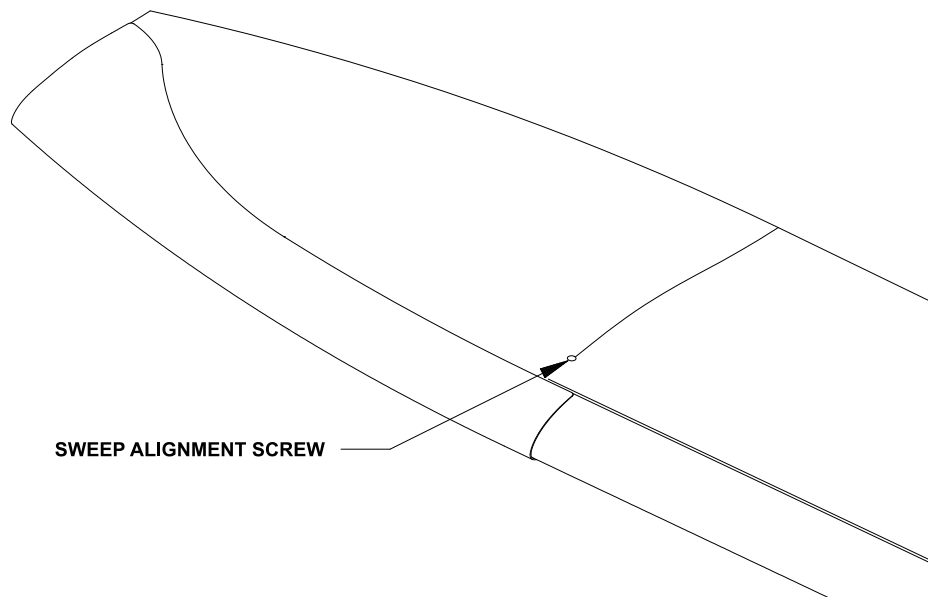
The 20631000-101 main rotor blade incorporates an alignment drive screw positioned on the upper surface of the blade 20 inches inboard of the tip. See figure 62-2. Tape the alignment cord over the alignment screw.

Figure 62-2
Main Rotor Blade Alignment Mark

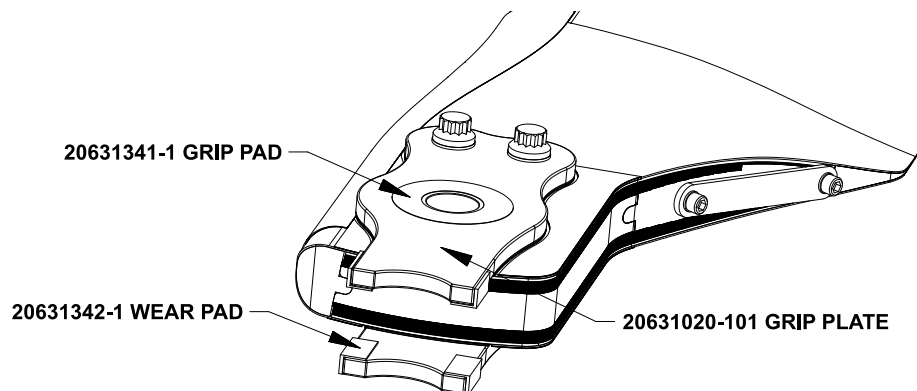
Contact VHA for 20631020-101, -103 grip plate assembly, 20631391-1 bushing, and 20631392-1 bushing replacement.

Figure 62-3
Main Rotor Blade Root Assembly
