INSTRUCTIONS FOR CONTINUED AIRWORTHINESS

ICA MANUAL No. VMM-MR-206B-501

Main Rotor Blade Assembly 20631000-101
Eligible for Installation on Model 206B

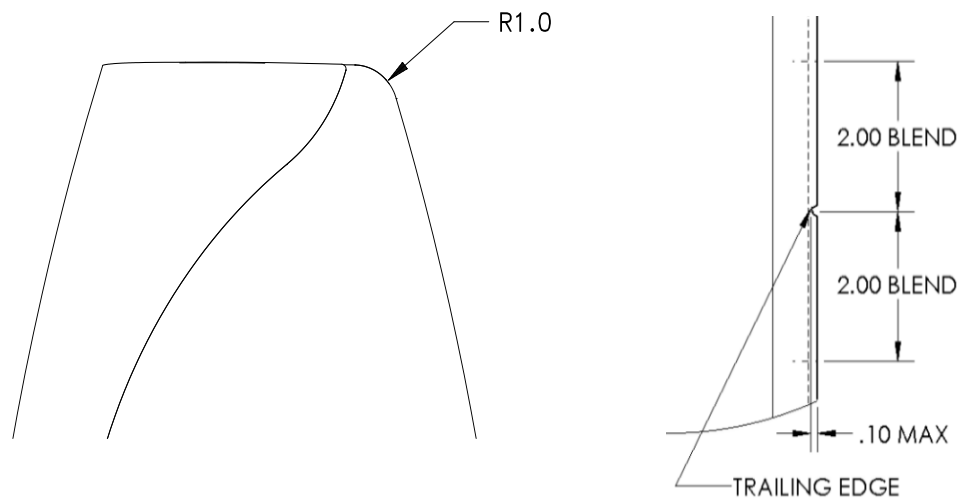
Figure 5-2

Tip and Trailing Edge Damage Limits

- c. Trailing Edge Damage
 - i. Scratches, nicks, or fiber damage in the extreme trailing edge 0.10 deep or less may be blended out over a distance of at least 2.0 inches each side of the damage. See Figure 5-2.

- ii. Damage at the tip trailing edge may be removed by blending up to a 1.0 inch radius at the tip. See Figure 5-2.
- d. Erosion damage to the skin plies occur when the paint layer has been compromised, exposing the skin plies to particle and water abrasion. All erosion damage to the carbon/epoxy skin plies must be repaired at the next maintenance interval. In the interim, protect all exposed fibers by applying epoxy primer to the damage area.
