INSTRUCTIONS FOR CONTINUED AIRWORTHINESS

ICA MANUAL No. VMM-MR-206L-501

Main Rotor Blade Assembly 20633000-101
Eligible for Installation on Model 206L, 206L1, 206L3, and 206L4

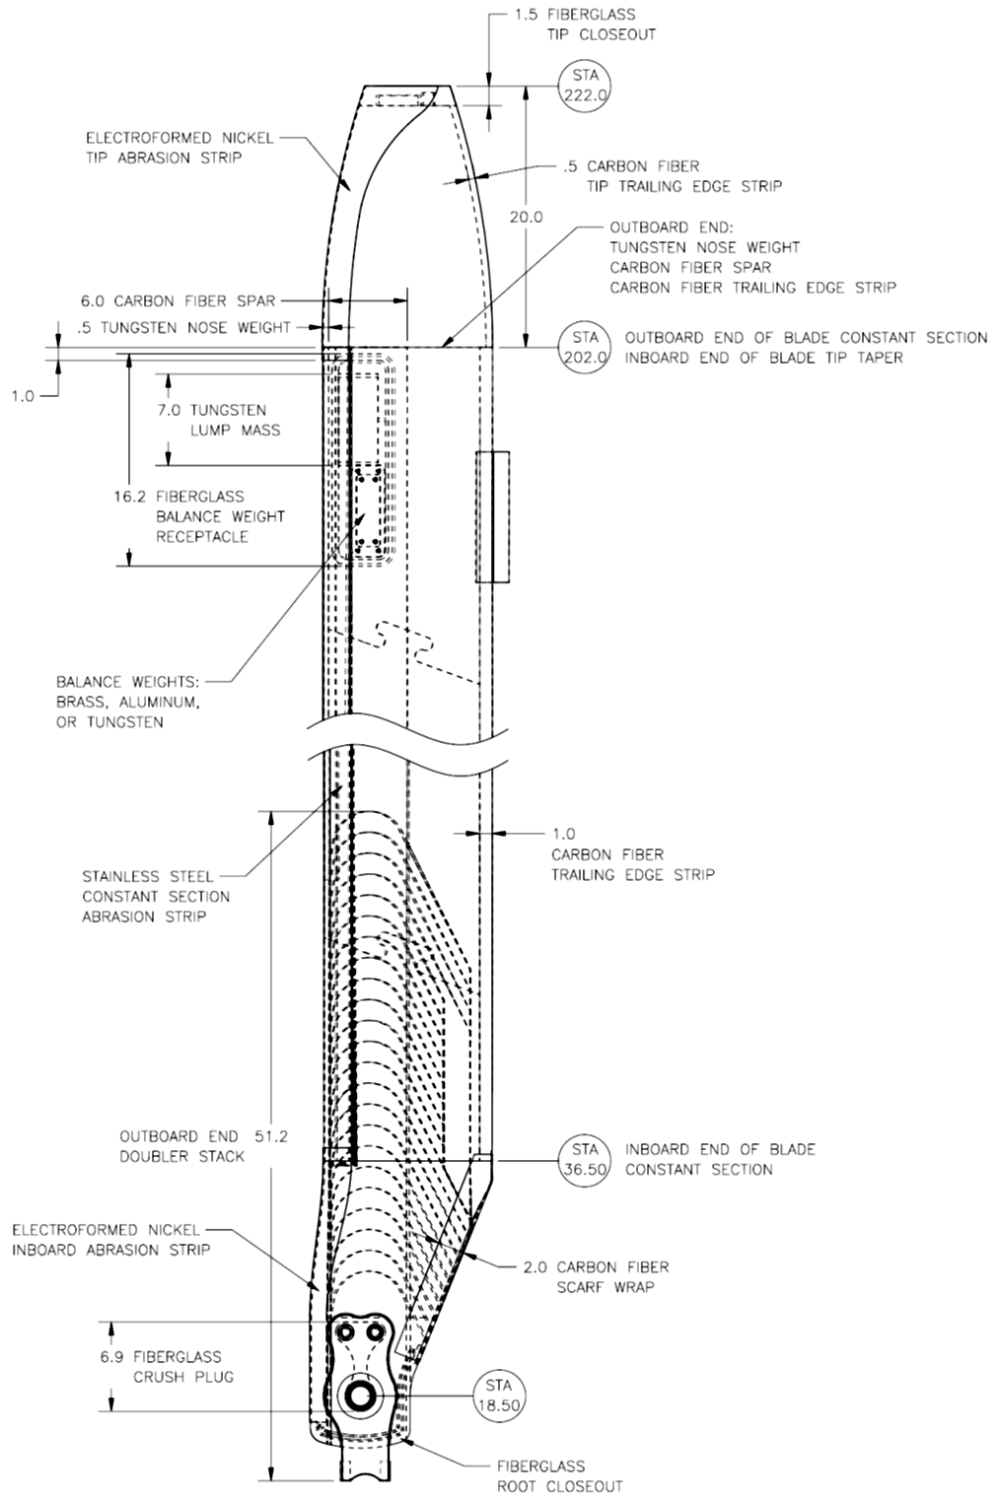
*The internal structure of the blade will cause tone changes during the tap test. Figure 5-1 shows the blades' internal components with their approximate locations and shapes. Other than the components shown, the remainder of the blades' internal structure is high density structural foam. Tone changes can be expected as the tap test traverses the various blade sections. Tone changes that are not associated with internal component boundaries should be treated as suspected voids.

Figure 5-1
Blade Internal Component Locations and Shapes

No.	Inspection Requirements	Airworthiness Criteria
1.	Inspect grip plate assemblies, root plates, and bushings for cracks. Conduct a tap test of blade upper and lower surface*.	Contact Van Horn Aviation if any discrepancies found exceeding damage limits in 5.10 and for grip plate assembly installation instructions.

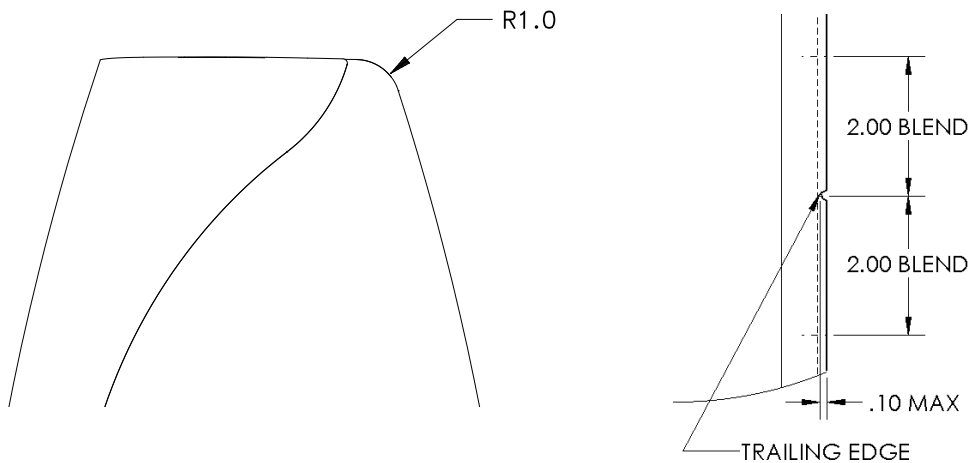
- a. Voids are not allowed within 1.0 inch of the trailing edge.
- b. Voids not exceeding 1.0 inch diameter are acceptable at any spanwise location.
- c. If voids are detected, remove paint in the damaged area to check for broken fibers. Remove paint and primer only. Do not sand into skin plies.
- d. Broken fibers are not permitted. If broken fibers are detected, send blade to an authorized FAA repair station for evaluation, and if possible, repair. Contact VHA for repair station recommendations
- e. Scratches, nicks, or fiber damage in the extreme trailing edge 0.10 deep or less may be blended out over a distance of at least 2.0 inches each side of the damage. See Figure 5-2 below.
- f. Damage at the tip trailing edge may be removed by blending up to a 1.0 inch radius at the tip. See Figure 5-2 below.

Figure 5-2
Tip and Trailing Edge Damage Limits

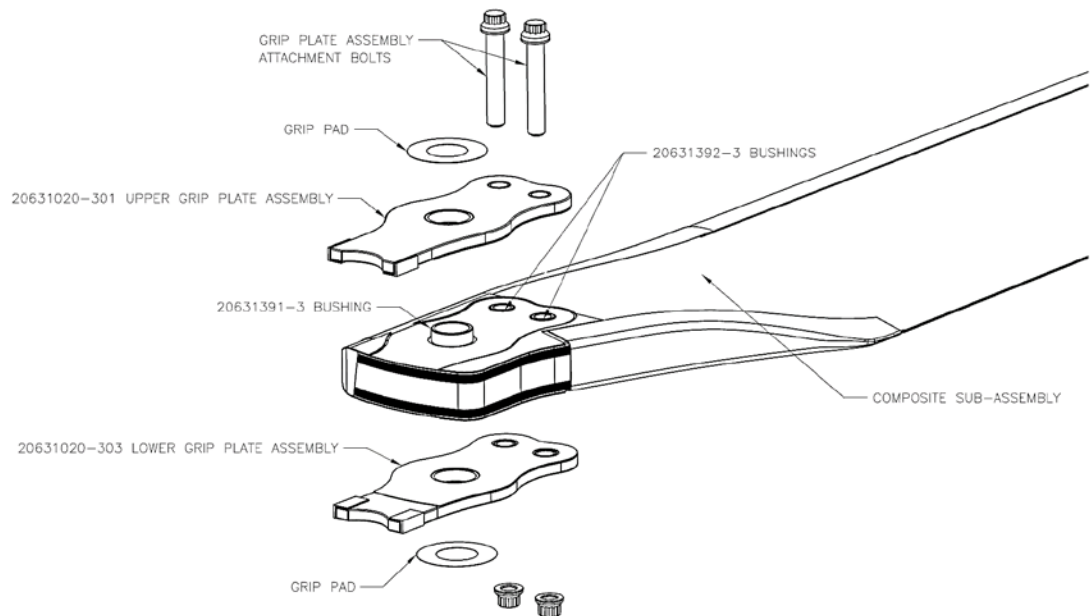
The 20633000-101 main rotor blade is a composite and metallic structure incorporating the NASA-developed RC(4)-12(12% thick) rotor blade airfoil. This is a highly efficient laminar flow airfoil developed to have near zero pitching moments across a broad range of airspeeds. The blade radius and chord is the same as the existing production blade except that the tip of the blade is tapered to reduce noise and tip drag. The root fitting is machined titanium alloy plate fastened to the blade root using two .750-inch bolts. Stainless steel bushings are bonded into the root of the blade. The basic blade section is fabricated using unidirectional carbon/epoxy tape and plain weave carbon/epoxy fabric with a rigid cell structural foam core. Span balance is accomplished using weight added in a tip weight pocket. Electroformed nickel and stainless steel abrasion strips are added for erosion protection.

Figure 62-1
Main Rotor Blade Description

Three abrasion strips are used on the leading edge. The electroformed nickel inboard abrasion extends from near the inboard end of the blade to approximately STA 37.0. It overlaps the stainless steel constant section abrasion strip which starts at STA 36.0 and extends to STA 202.0. The electroformed nickel tip abrasion strip starts at approximately STA 201.0 and extends to the blade tip. It overlaps the constant section abrasion strip. The criteria below apply to all three abrasion strips.

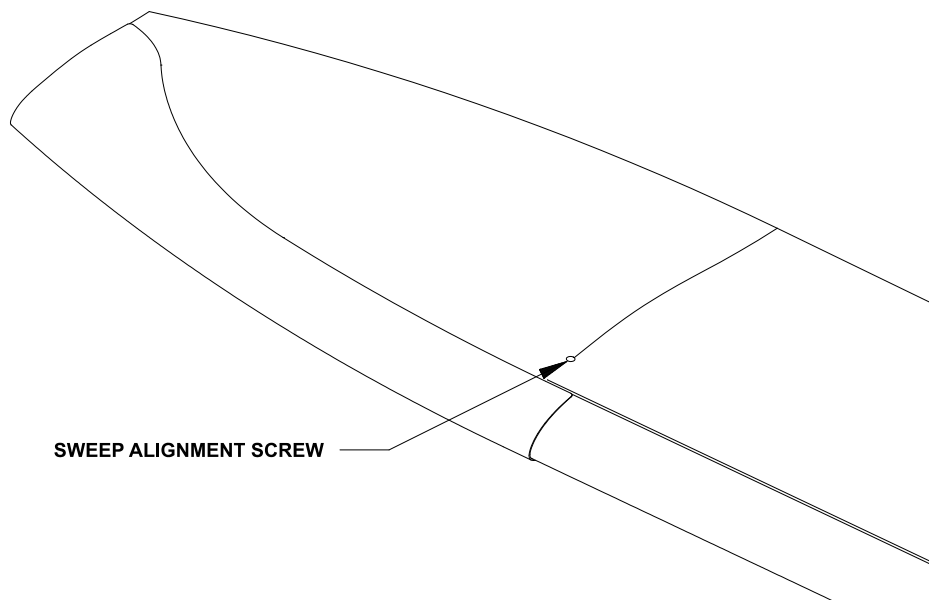
The 20633000-101 main rotor blade incorporates an alignment drive screw positioned on the upper surface of the blade 20 inches inboard of the tip. See figure 62-2. Tape the alignment cord over the alignment screw.

Figure 62-2
Main Rotor Blade Alignment Mark

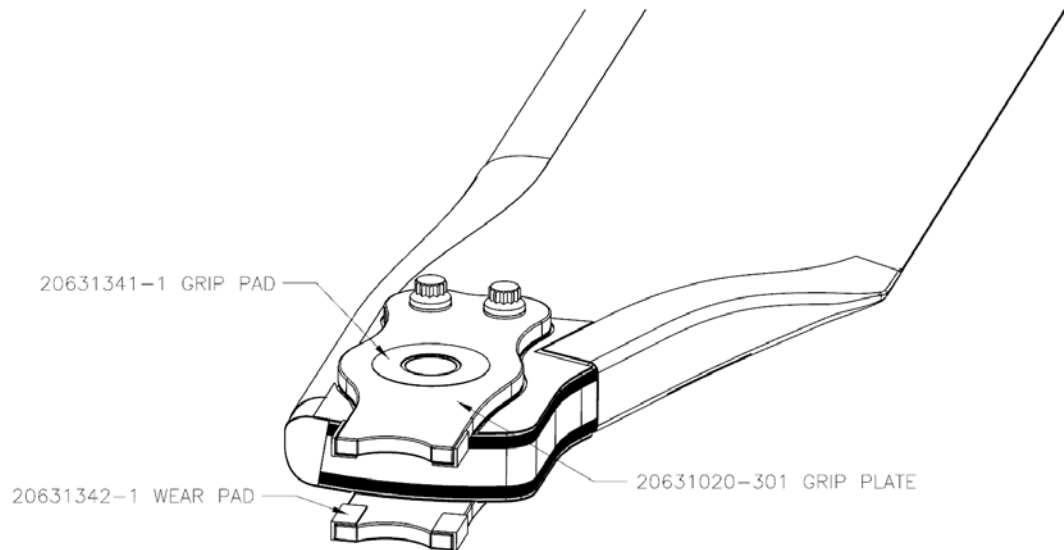
Figure 62-3
Main Rotor Blade Root Assembly

Grip Pad 20631341-1 (see figure 62-3) may be replaced with Bell grip pad 206-010-233-005. Install either the VHA or Bell grip pad according to the current FAA accepted component repair and overhaul (CR&O) manual for the existing production main rotor blade 206-015-001-ALL with the following exceptions and recommended practices.

Wear pad 20631342-1 (see figure 62-3) may be replaced with Bell wear pad 206-010-242-003. Install either the VHA or Bell wear pad according to the current FAA accepted component repair and overhaul (CR&O) manual for the existing production main rotor blade 206-010-200-ALL with the following exceptions and recommended practices.

Contact VHA for 20631020-301, -303 grip plate assembly replacement.
